Environmental Impact Study of Two Tannery Estates on the Buriganga and the Dhaleshwari Rivers

Final Report

June 2018

Department of Environment
Ministry of Environment, Forest and Climate Change
Government of the People's Republic of Bangladesh

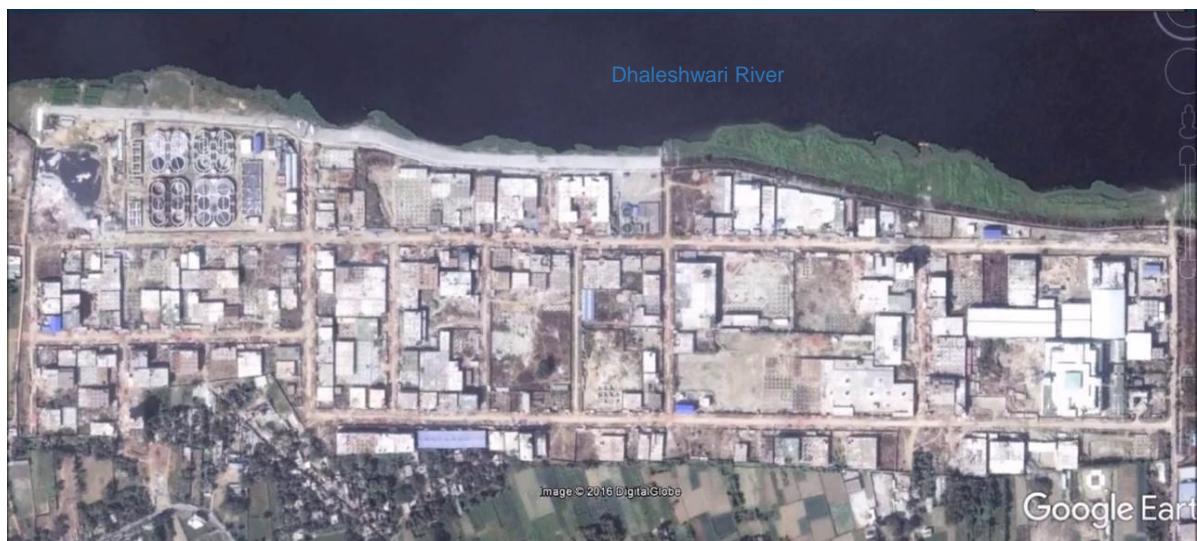
Figure 1.2: Savar Tannery Cluster, which is situated on the Bank of Dhaleshwari River

Savar Tannery Estate is situated at Horindhara on the bank of the Dhaleshwari River. A total of 200 acres of land has been developed for 195 industrial plots in 4 different categories (category A-D) considering the plot size. STE includes industrial plots, CETP, disposal yard, administrative building, drainage facility and sub-station for electricity supply to the industrial units. European Union (EU), obliged to install CETP by June 2014 in a functional mode, which was found incomplete with its poor construction materials, and faulty design in respect of treating all the pollutants coming from tannery effluents (Speaker of the parliament, December 2017).

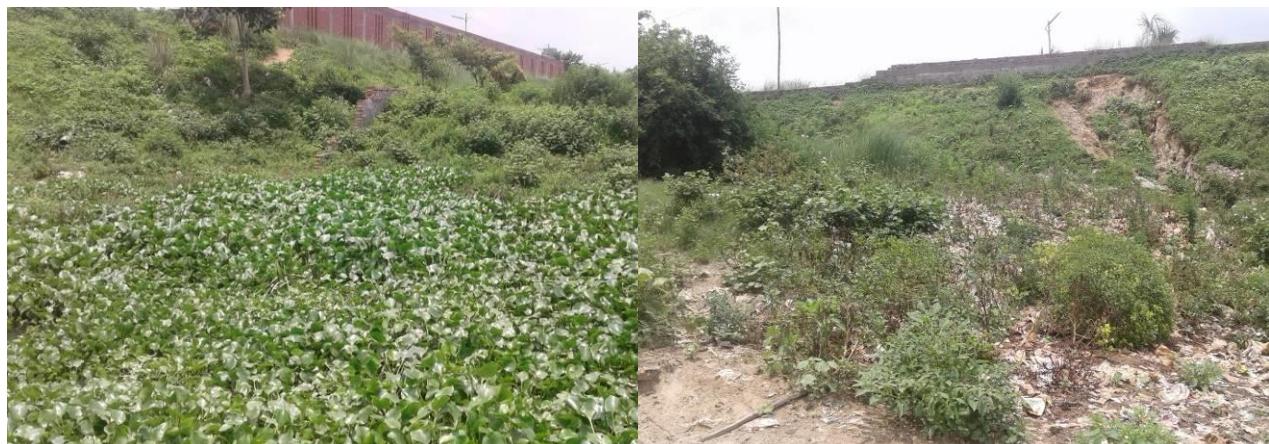
Figure 2.13: Existing vegetation pattern of Hazaribagh Area

Submerged plants disappeared from the Buriganga River reaches near Hazaribagh. Heavy amount of industrial waste deposition on riverbed and low penetration of light for polluted dark water disfavor growth of submerged vegetation in rivers surrounding the Dhaka City.

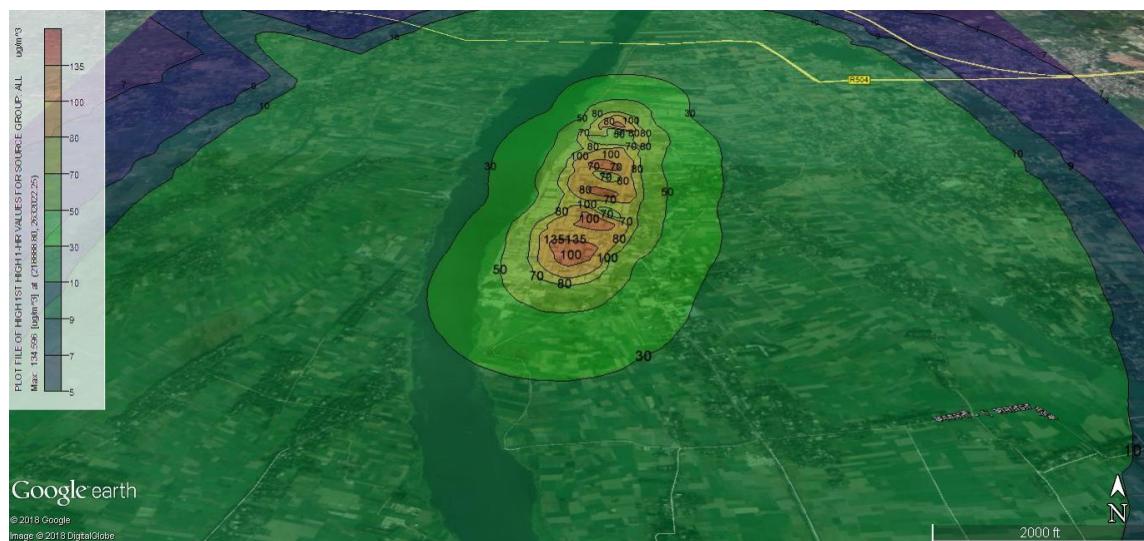
Volatile Organic Compounds are emitted in finishing operation including formaldehyde, benzine acetone, butyl acetate, isopropyl alcohol etc. In tanneries operators frequently handle organic solvents with bare hand and without nose mask; they are suffering in various difficulties like abdominal pain, diarrhea, convulsion and respiratory problem. Although most of the developed countries have reduced the use of formaldehyde (H-CHO) as well set a permissible level in leather. Tanneries of Bangladesh also use formaldehyde and other organic solvents. The maximum dispersion area of VOCs concentration has been shown in **Figure 3.10.**

Figure 3.10: Maximum Concentration of VOC after Dispersion from Savar Tannery Estate

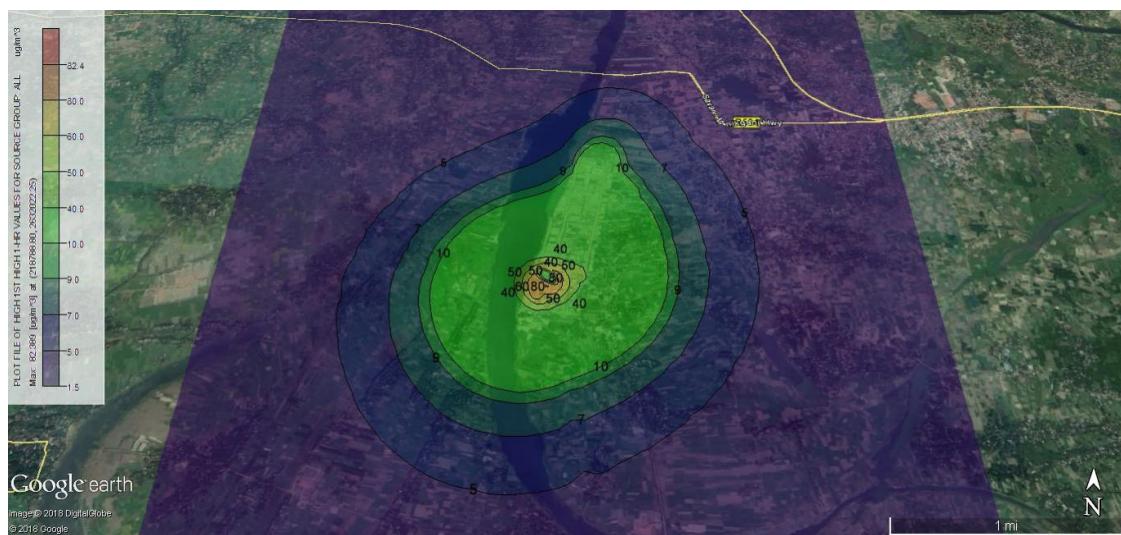
In tannery, normally unhairing and liming takes about 18–20 hours. During long time chemical reaction as well as mechanical agitation produces H₂S gas. The H₂S gas comes out from the hollow axle of drum/from open paddle which is directly mixed with air inside the tanning industry. It is a colorless gas and is slightly heavier than air. It has a strong Odor of rotten eggs. In tannery, operators are used to work without nose mask and frequently inhale gaseous H₂S and are suffering from difficulties. High concentration of H₂S (> 900ppm) for one-minute causes instant coma and death. The maximum dispersion area of H₂S concentration has been shown in **Figure 3.11.**

Figure 3.11: Maximum Concentration of H₂S after Dispersion from Savar Tannery Estate

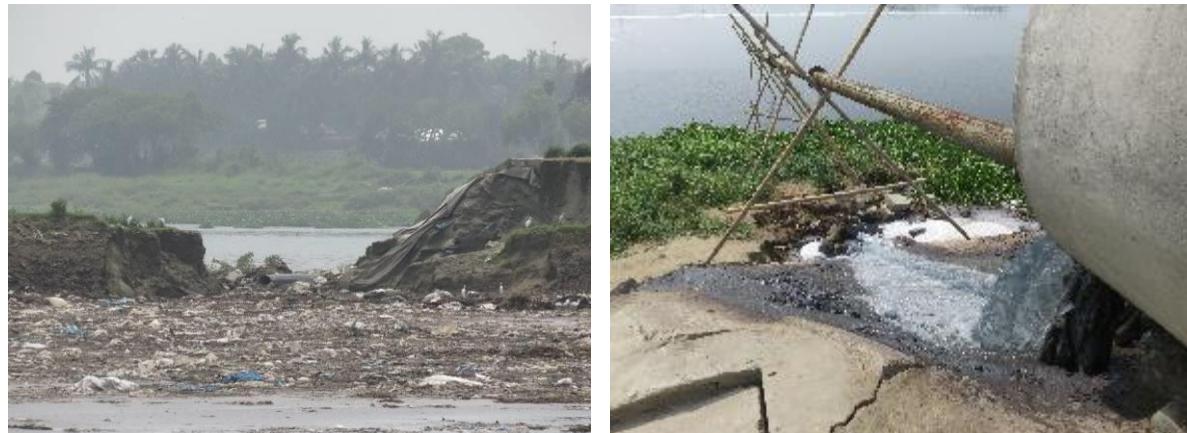
In case of the Dhaleshwari River, habitat suitability for fish has degraded due to poor condition of connectivity of water bodies, spatial and temporal water flow and velocity, substrates, water quality, aquatic vegetation, etc. Fish habitats are suitable from the month of July to September, and decline in the months of December to March. The river receives a large amount of industrial waste and agricultural pesticides. Although, the condition becomes worst from post-monsoon up to next monsoon season. However, the polluted bed material from Singair Bridge to lower stream in the vicinity of Tannery Industry results in decreasing the suitability for benthic fish community round the year. On the other hand, low water quality (having very low level of Dissolved Oxygen, described in water quality section) of the surface water results in unavailability of free floating and benthopelagic fish species during dry season.

Figure 3.14: Discharge of Industrial Effluent into the Dhaleshwari River

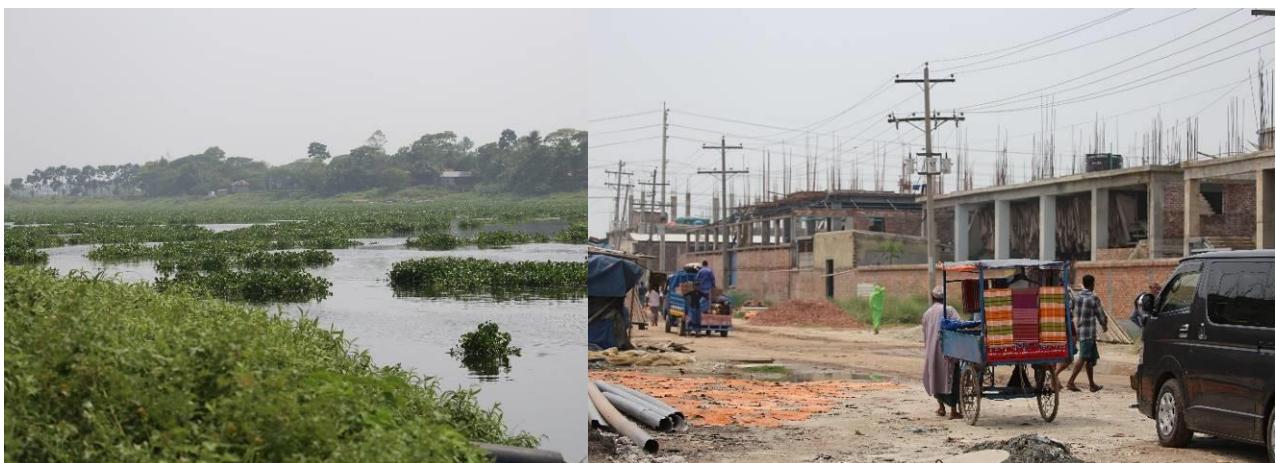
Figure 3.17: Existing vegetation pattern of the Haringdhara Site

Floral density and diversity were higher at Harindhara Tannery Estate and its surroundings than Hazaribagh Site. The Tannery Estate had very low vegetation coverage as their continuing the civil construction activities which caused barrier to grow vegetation. Only the corridors and river levees were vegetated with wild herbs like *Richardia scabra*, *Croton sp*, *Crozophora sp*, *Polygonum*, *Imperata cylindrica*, *Physalis minima* etc. The Tannery Estate ground did not possess big trees.

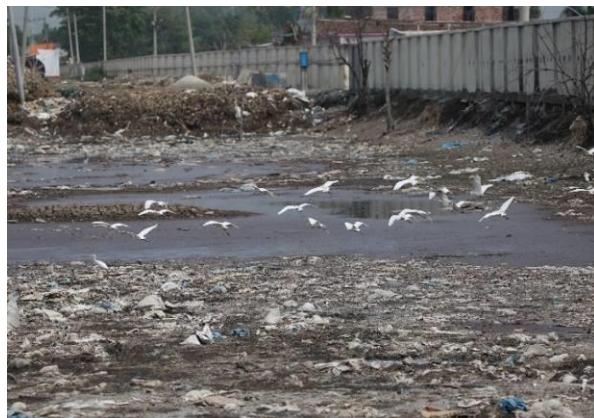
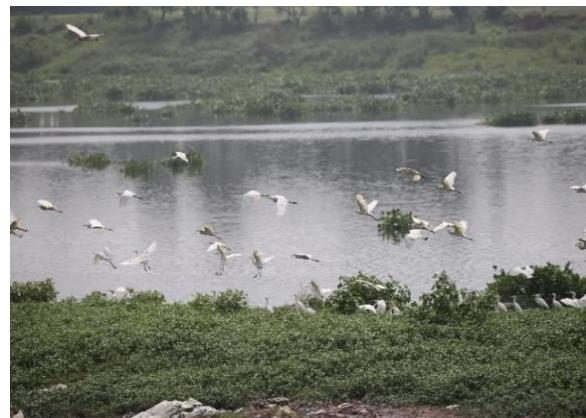
Figure 3.18: Egrets observed at solid waste dumping site at Harindhara Tannery Estate

Some birds were observed at Harindhara Tannery Estate during field visit. A colony of 20-30 numbers of Cattle Egrets was roaming at Solid Waste Dumping Site (**Figure 3.18**). In addition to this, a number of Asian Pied Starling and some Black Drungo were observed within the Tannery Estate. As per local people, the land of the Tannery Estate was the feeding ground of local birds like Bee Eater, Spotted Dove, Bristled Grass Bird, Greater coukal, Rufous Treepie etc before land development. Common Lizards within the site was Common Skink (*Mabuya carinata*) and the Garden Lizard (*Calotes versicolor*). The population of Grey Monitor (*Varanus bengalensis*) was healthy but now disappeared from the location. The population of snakes was not very rich as the river water was polluted during last decade due to industrial pollutants, and they had little shelter in this landscape due to urbanization. **Figure 3.19** represents some of the wildlife within the Harindhara Tannery Estate and different distance of its surrounding areas.

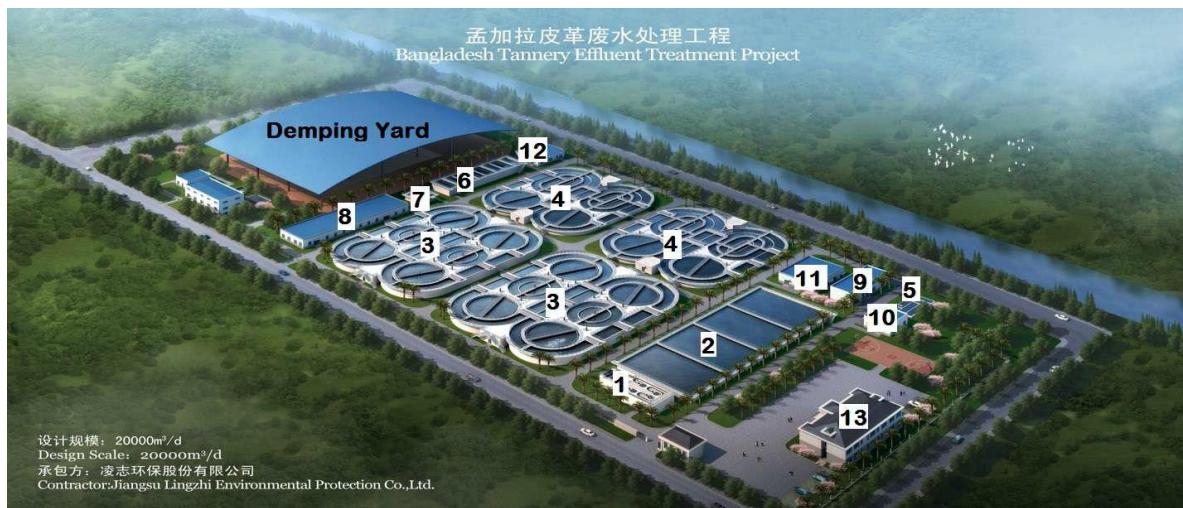
Figure 4.2: Design View of Common Effluent Treatment Plant (CETP) and Dumping (Disposal) Yard

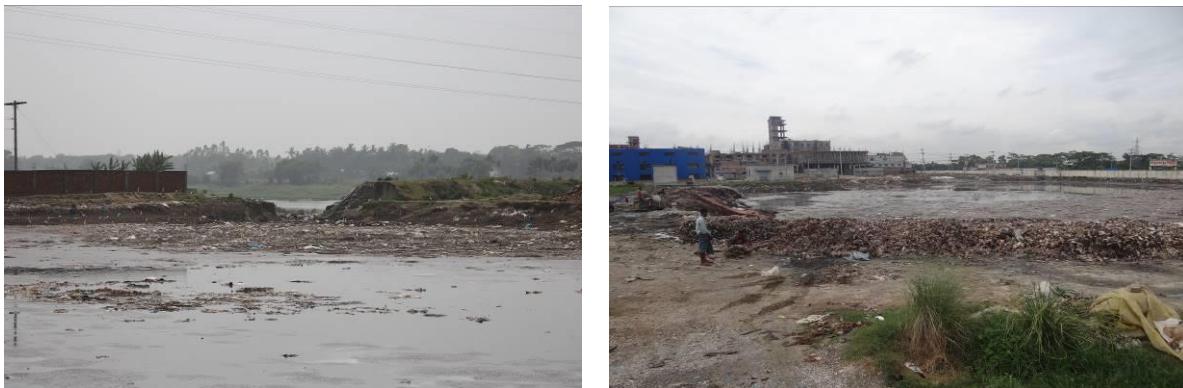
Figure 4.3: Solid waste disposal yard

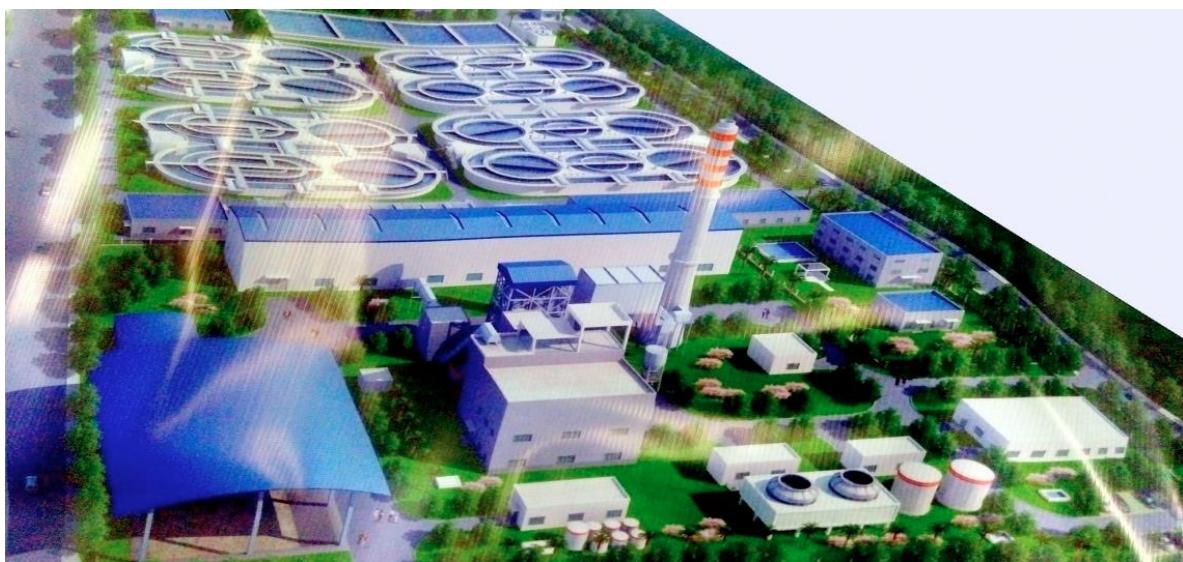
Figure 4.4: Layout Plan of SPGS (replacing Dumping Yard) building integrally with CETP

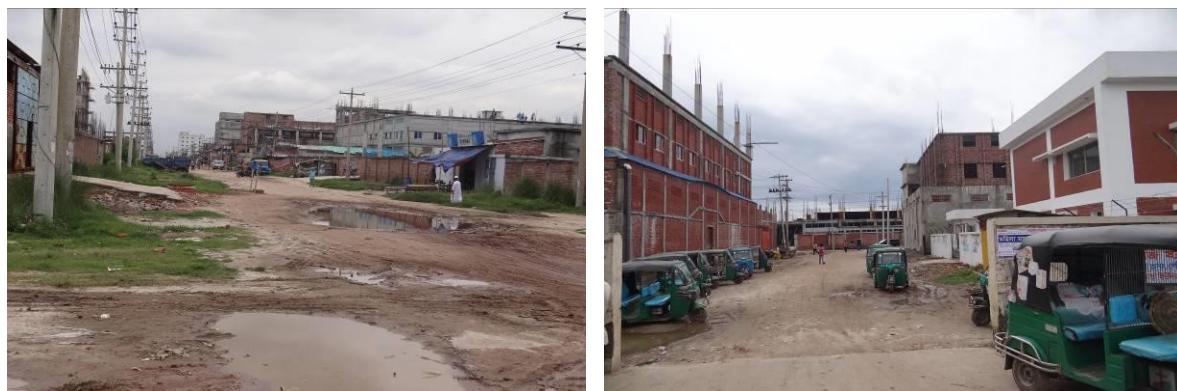
Figure 4.6: Real picture of internal roads of Savar Tannery Estate

Effectiveness: Inside the tannery estate, most of the roads are found in very bad conditions. Instead of paved road, there was only mud roads. In addition, the roads are damaged due to heavy truck and vehicles movement. In the rainy season, the situation even worse.

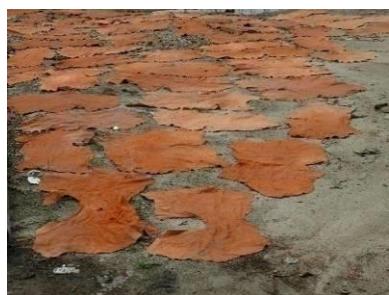
(a) Leather drying in field

Having all these issues, Savar Tannery Estate, is running in full swing, which ultimately are increasing pressures on natural resources of the adjacent environment. Some photographs of the observed situation are presented in **Figure A.1**.

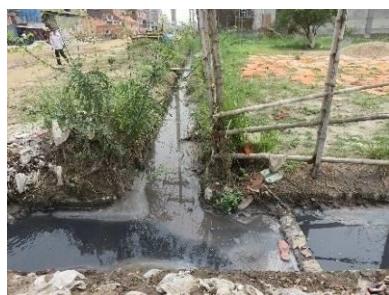
(b) Open drainage

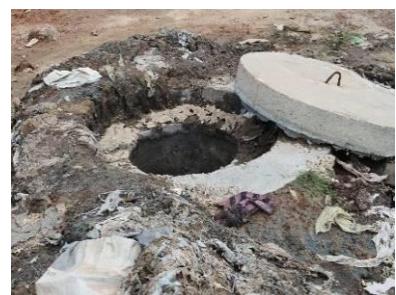
(c) Open manhole

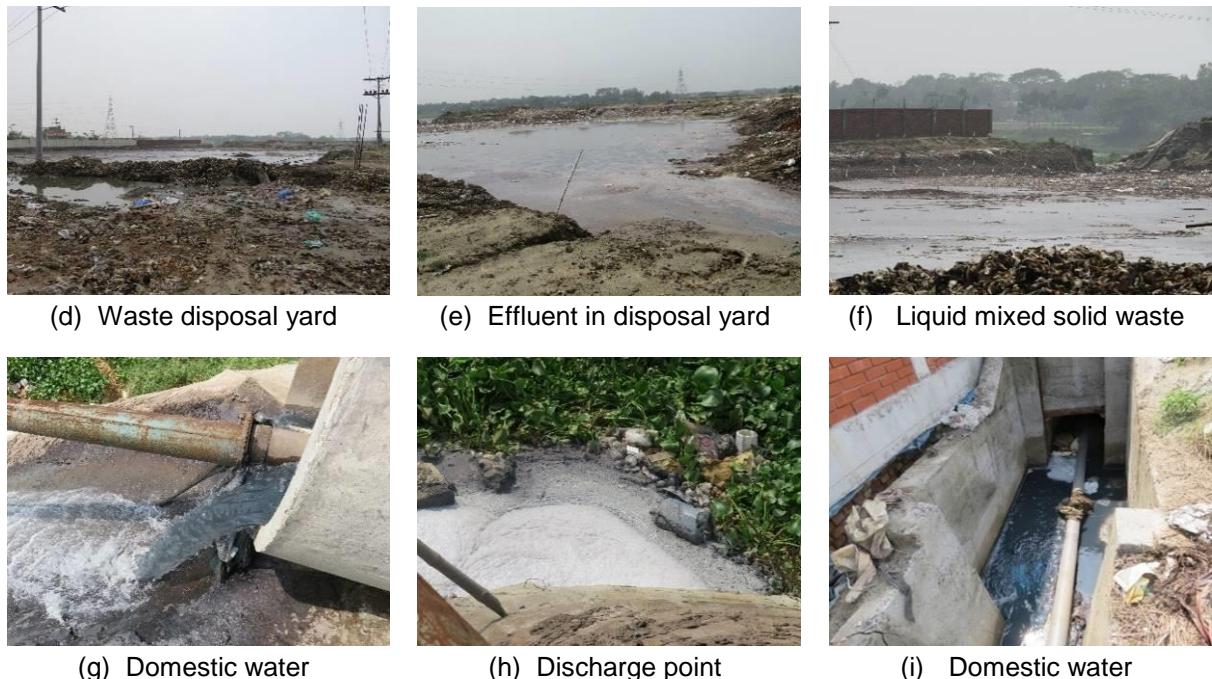
Figure A.1: Photographs of Savar Tannery Estate and its Various Issues

Fourthly, the CETP is not functional fully due to saline water coming from the washing of raw hide and skin in tannery. Saline water treatment facility was not in the design of CETP. Therefore, effluents from CETP are being released at night directly to solid waste disposal yard due to low efficiency of CETP. This creates very bad smell in the air by rotten leather. **Lastly**, these solid mixed effluents are being released into Dhaleshwari River directly through cutting the earthen barricade of disposal yard. Moreover, there is high chance of leaching heavy metals (Cr) and other pollutants into Dhaleshwari and into groundwater. Domestic water is also released into Dhaleshwari River without any treatments.

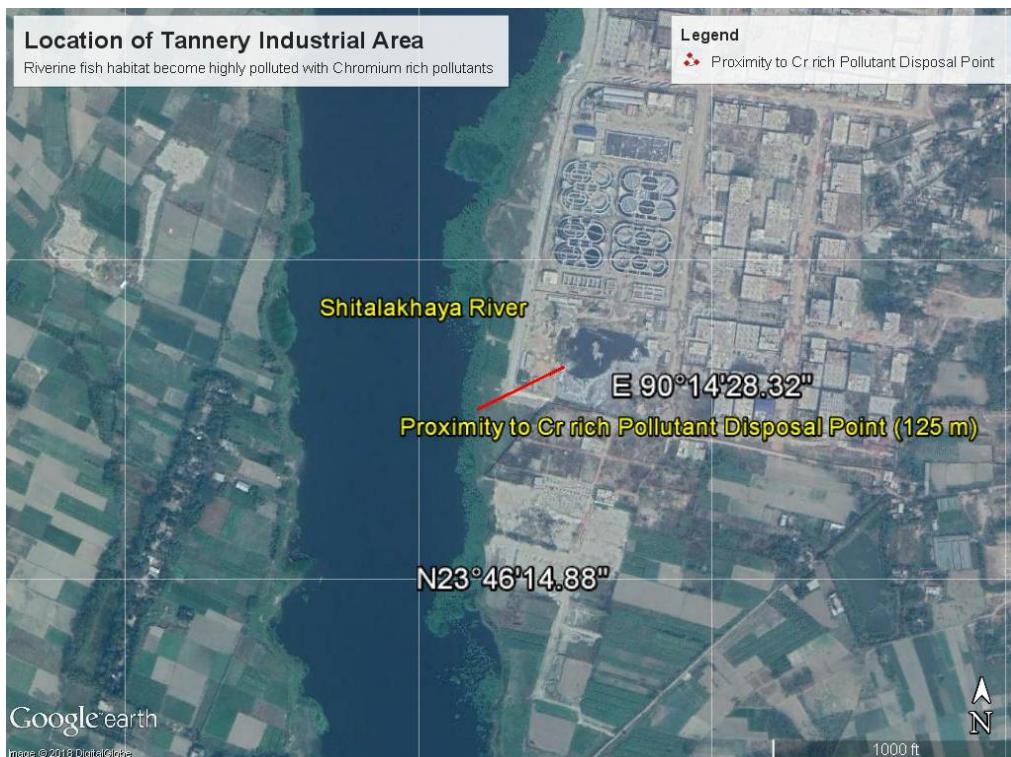
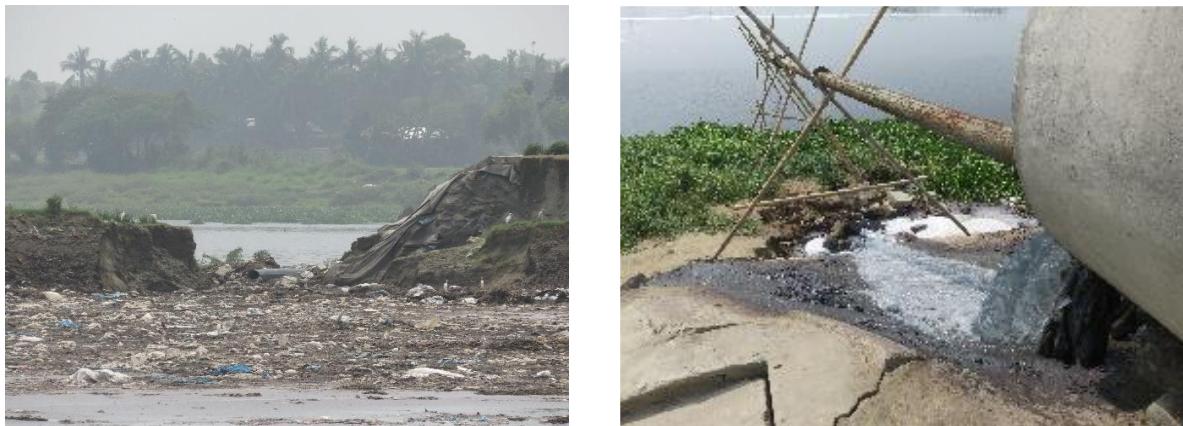
Figure A.3: Proximity of Dhaleshwari River System to Heavy Metal Discharge

The tannery industrial area is located beside the Dhaleshwari River, which serves as the major capture fish habitat for the surrounding area. The local people reported that there are more than 50 riverine fish species in the river system. It was found, however, that the habitat quality of river have become highly susceptible to heavy metal rich pollutants, which are, supposed to be mutagenic trace element for various riverine fish species (**Figure A.2**). About 125m breach of protective bank was observed at a place adjacent to the Solid Waste Disposal Station indicating that high Cr rich pollutant directly falls in to the river system.

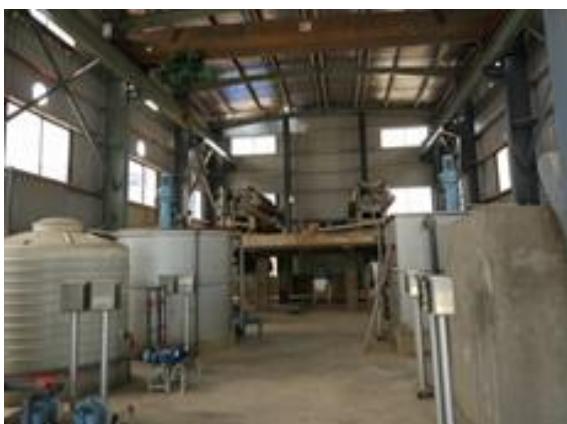
(a) Effluent Pumping Station

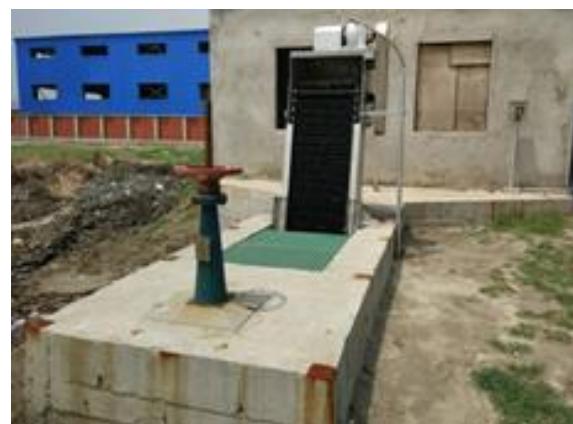
Figure A.4: Equipment Facilities in CETP

(b) Mechanized way to filter solidwaste from effluents
